RESEARCH AND DEVELOPMENT REPORT

# Evaluation of Flame Propagation of Retrofit Energy Efficient Wall Assemblies

April 19, 2024

Prepared for the International Association of Fire Fighters in fulfillment of Department of Energy Grant DE-E0009454

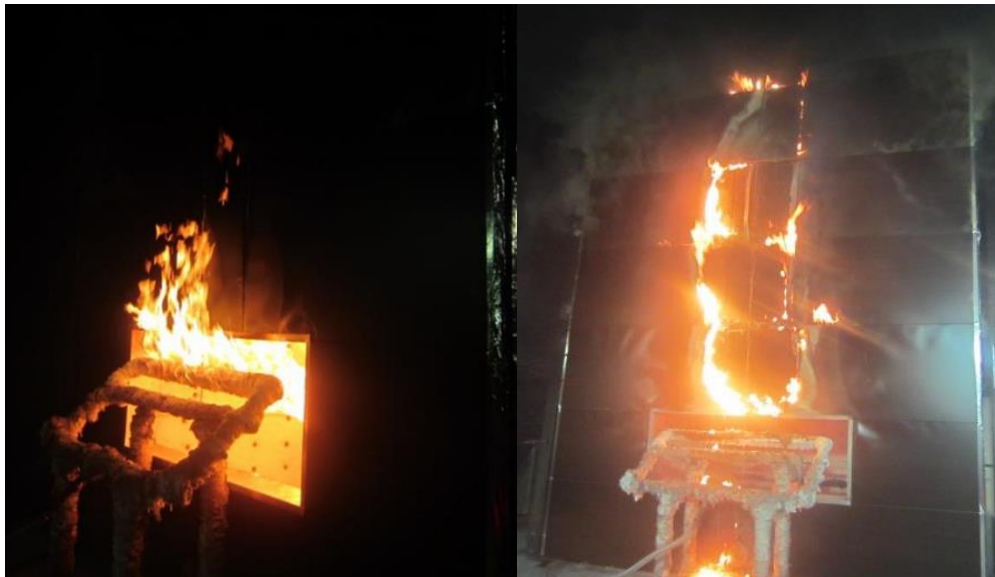
Figure 2 - Photographs of NFPA 285 Tests

The test apparatus is a two level structure. Two gas burners are used, one inside the first story room and the other near the top of the window opening. The wall test specimens are secured in a movable, steel test frame for testing. The specimens are at least 17 ft 6 in. high and 13 ft 4 in. wide and contain a 30 in. tall and 78 in. wide window opening at the first floor level. The samples are secured to the front of the two story test apparatus. Temperature is measured on the exterior wall surface, combustible insulation, cavity air space, wall and stud cavity insulation, and interior surface of the test specimen as applicable. Temperature is also measured inside the first and second story test rooms.

The test procedure is to ignite the test room burner. Five minutes later, the window burner is ignited. Thirty minutes later the burner are turned off. During the entire test duration, the assembly shall not spread flames “vertically or horizontally beyond the area of flame plume impingement by the window burner flames” or vertically or horizontally “through the combustible components or the combustible insulation installed within the test specimen” as verified by limits on the temperatures measured on and in the test specimen [8]. Additionally, temperatures cannot exceed 500°F (278°C) above the ambient air temperature an inch into the second story opening, “flames shall not occur in the second story test room”, and “flames shall not occur beyond the intersection of the test specimen and side walls of the test apparatus. [8]”

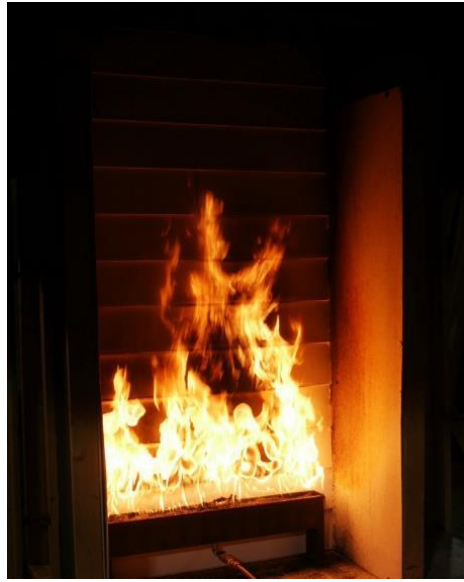
Figure 3 - Photograph of ASTM E2707 Test

The test method defines the test specimen to be 4 ft (1.2 m) by 8 ft (2.4 m) in size. The fire source is a slotted gas burner set to 150 kW placed at the bottom of the test specimen such that the flame can impinge on the exterior of the test specimen. The specimen is exposed to the fire for 10 minutes. The test specimen is observed for the absence of flame penetration through the wall assembly & absence of glowing combustion on the interior surface at the end of the 70-minute test (1 hour observation period).

The test method is designed to evaluate fire penetration into an exterior wall. It does not, however, evaluate fire propagation (spread) vertically up the wall or horizontally across the wall.

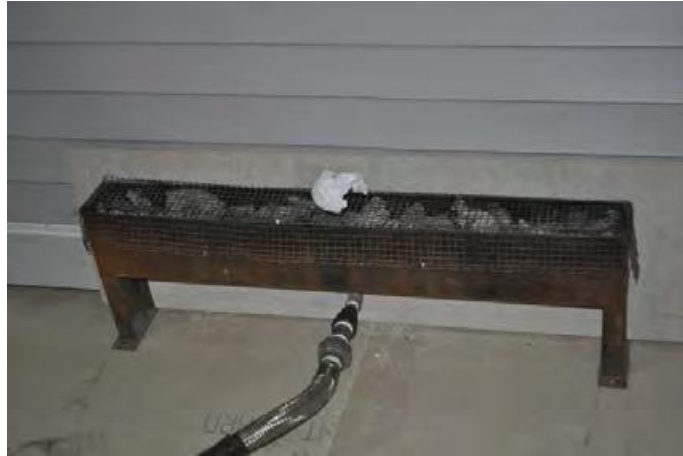
**Figure 10 - Photograph of the 39 inch (1 m) Gas Line Burner [7]**

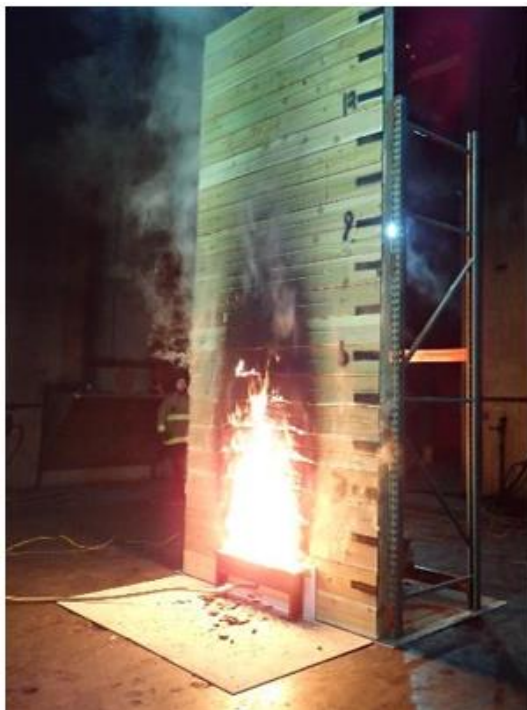
Figure 11 - Photograph of a Modified ASTM E2707 Fire Experiment

Eight co-sponsored experiments were conducted to refine the draft, modified ASTM E2707 test method. These experiments studied four different ignition burner fire sizes with a combination of different common exterior wall materials. Some experiments were conducted with insulation and interior gypsum board and others without. The sidings investigated were vinyl and 8 inch (20 cm) wood lap siding. Three WRB conditions were investigated - polyethylene fiber barrier, construction paper, and none. Oriented strand board (OSB) or plywood was used as sheathing. In the tests with insulation, fiberglass was used. Lastly in one test, 1 inch (25 mm) extruded polystyrene (XPS) was applied under the vinyl siding to simulate continuous insulation. In each experiment the wall assembly was wood framed and 8 ft (2.4 m) wide and 16 ft (4.9 m) in height. 2 by 4 lumber was used. The studs were 16 inch (41 cm) on center. The siding was attached with fasteners at a nominal 8 inch (20 cm) on-center and included staggered joints at vertical centerline of assembly. The same line burner (Figure 10) used in the UL FSRI study was used in this series of experiments. The burner was left on for 20 minutes in each test. The experimental test matrix can be found in Table 3. A photograph of an experiment is presented in Figure 11.

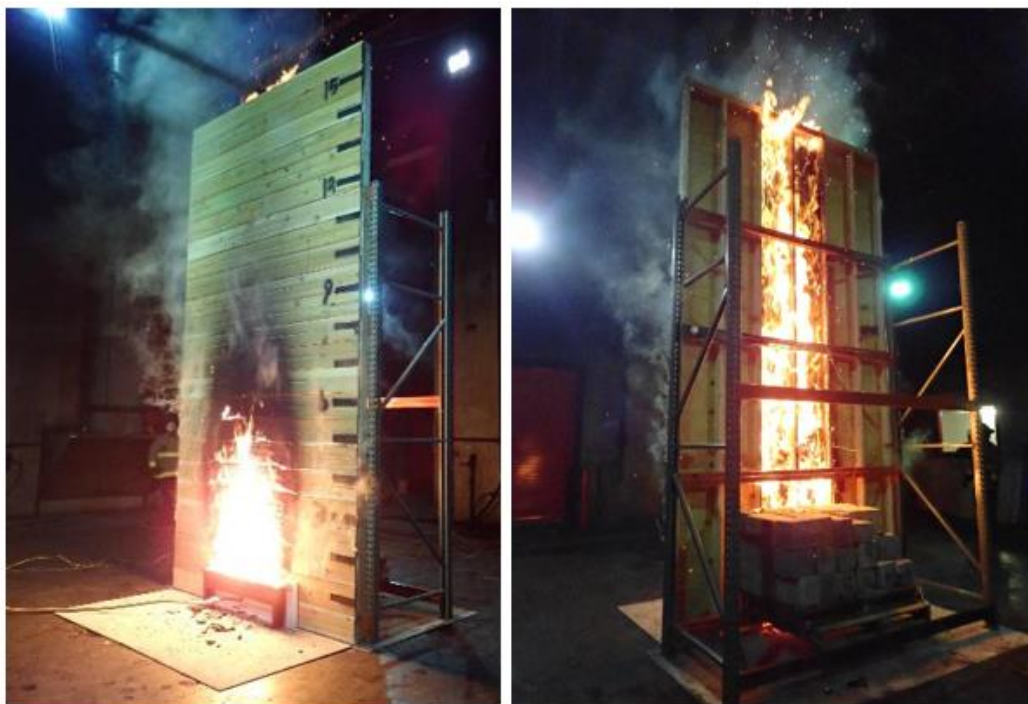
Figure 12 - Photographs of Fire Burning through Test Sample

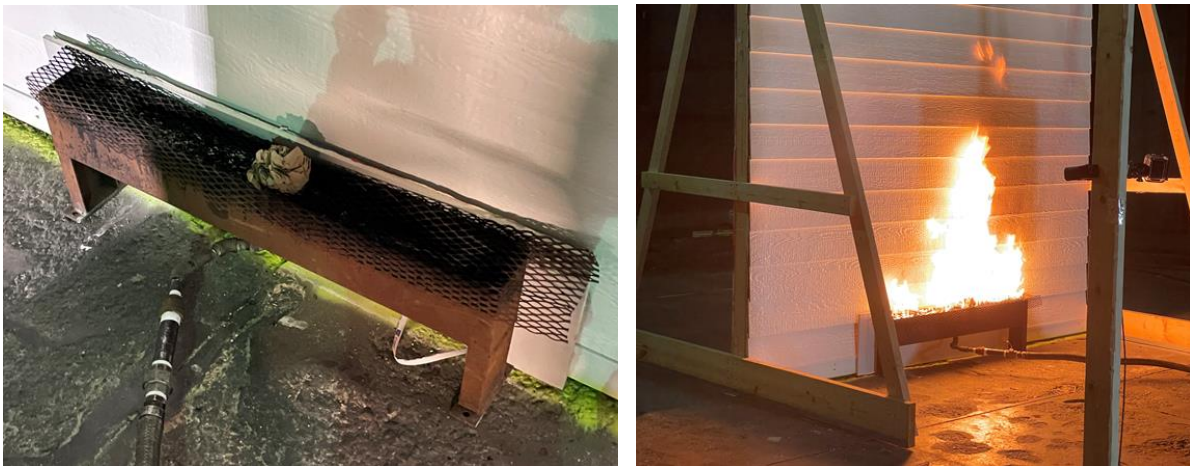
Figure 18 - Photographs of the Test Burner and 75kW Ignition Fire

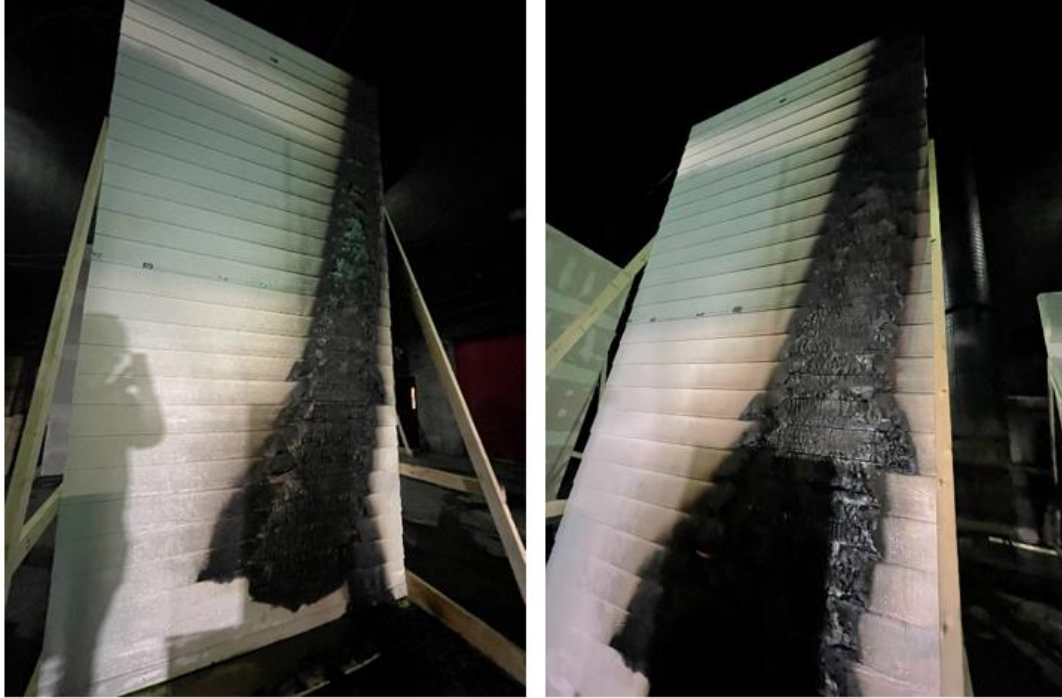
**Figure 19 - Post-test Photographs of Test 1 Wood Composite Siding/Asphalt Paper Wall Assembly with 75 kW Ignition**

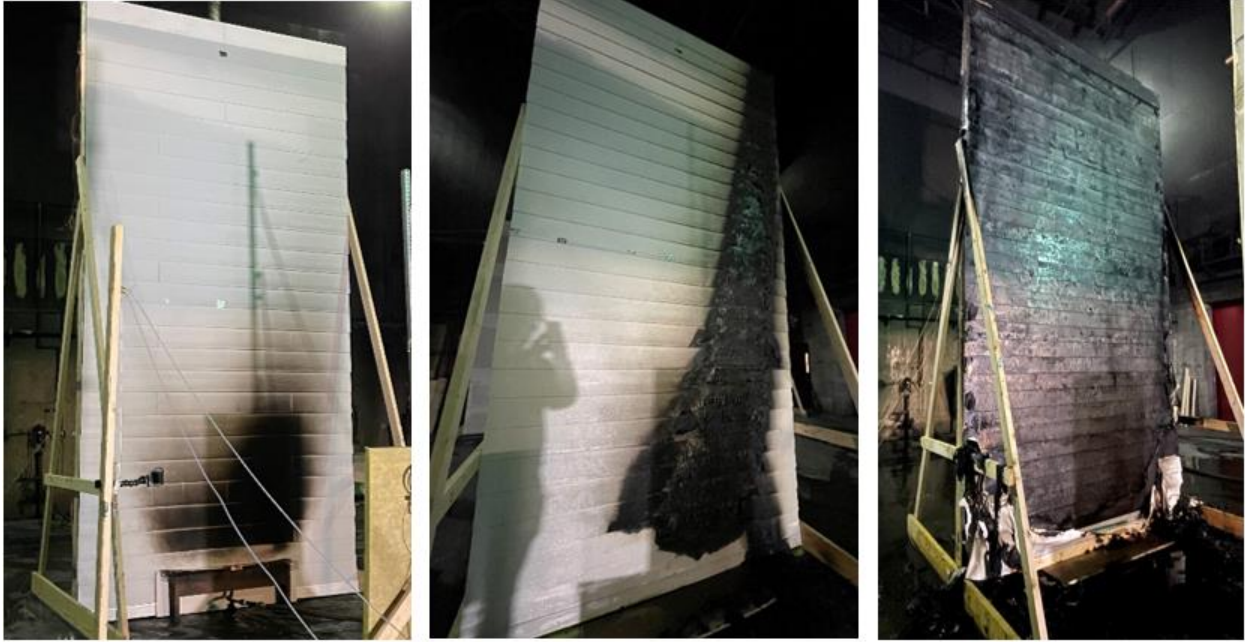
**Figure 32 - Side by Side Post-test Photographs from Test 1 and Tests 3-4 of Similar Wall Assemblies with Different Siding - Fiber Cement, Wood Composite, and Vinyl (Left to Right)**

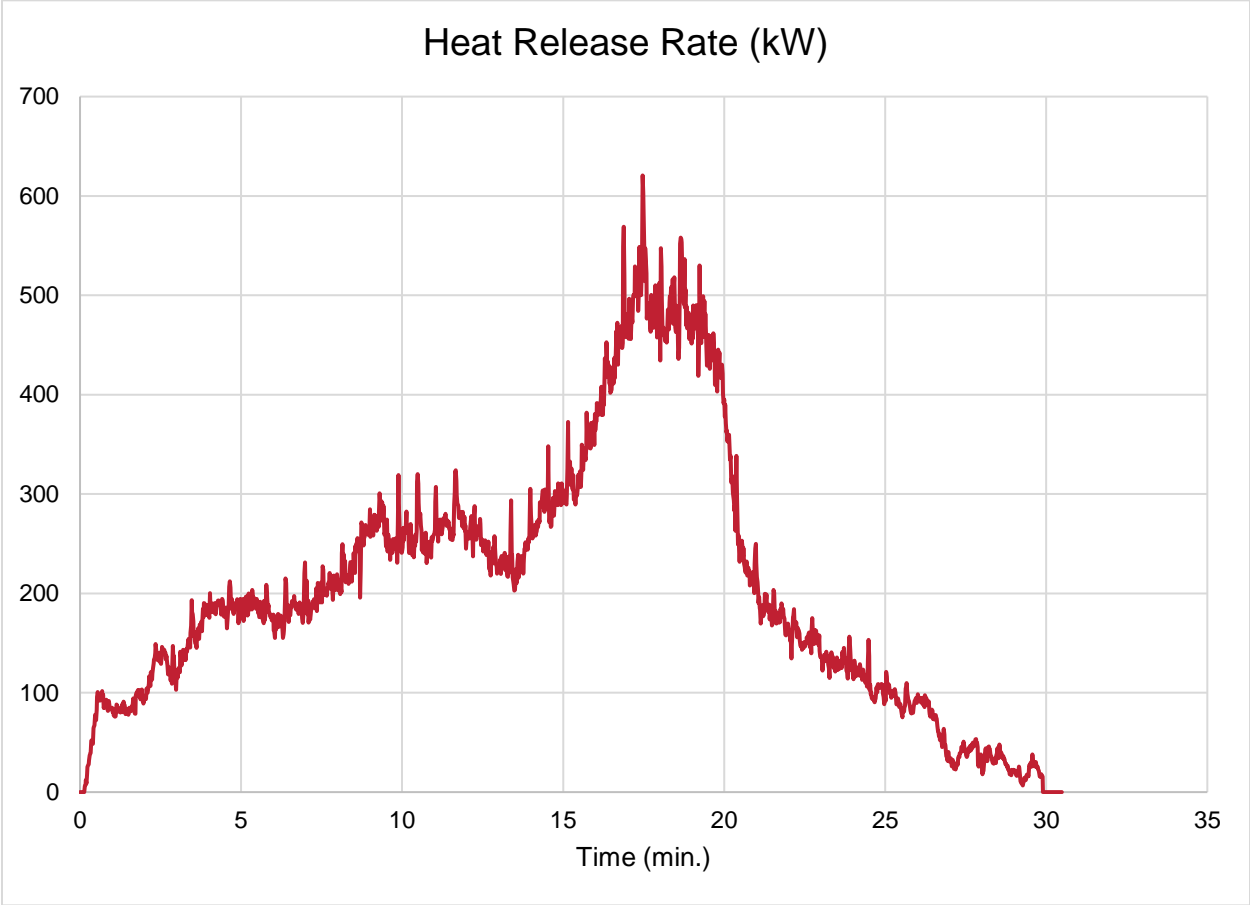
Figure 72 - Test 1 Wood Composite Siding/Asphalt Paper (75 kW) Heat Release Rate Plot

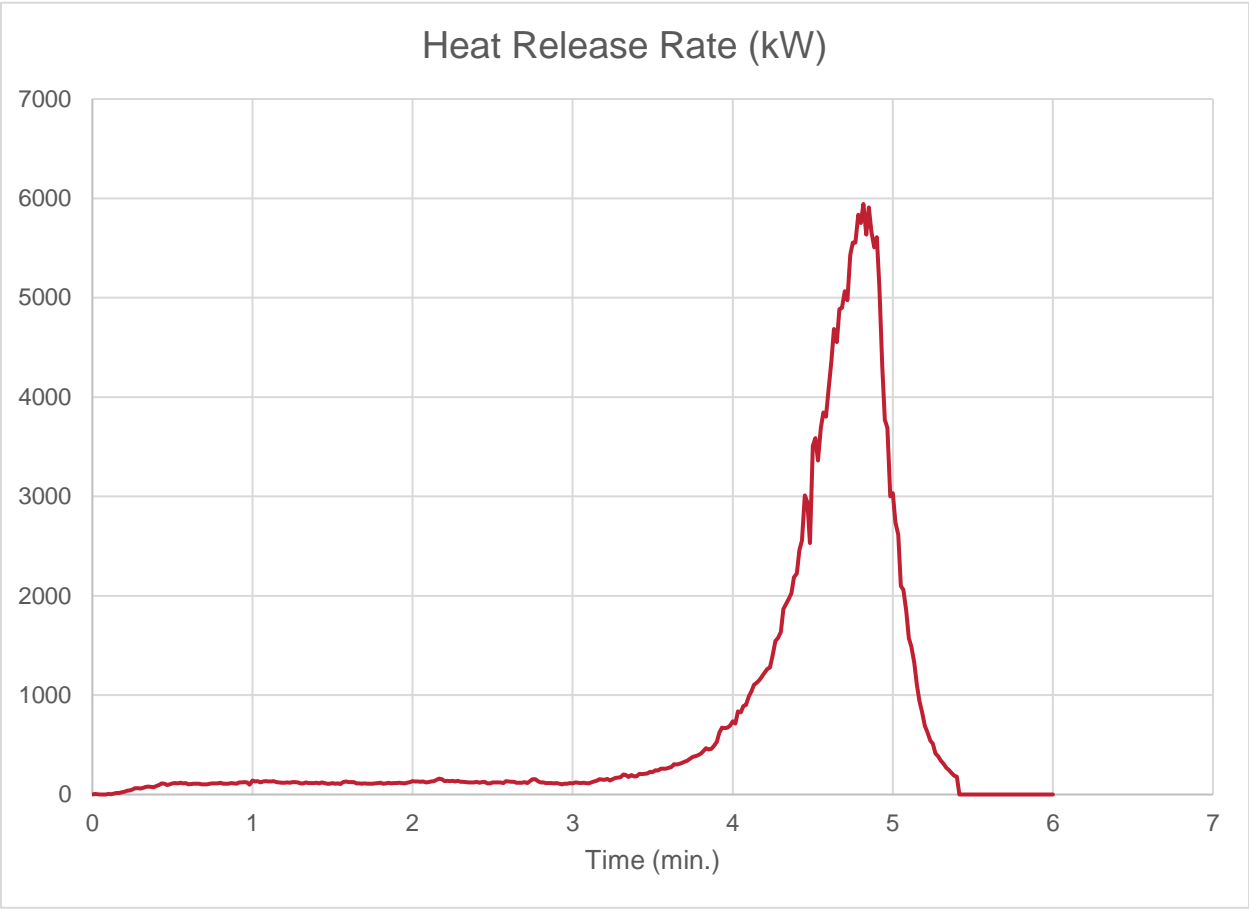
**Figure 77 - Test 6 Vinyl Siding/EPS/Mineral Wool Heat Release Rate Plot**

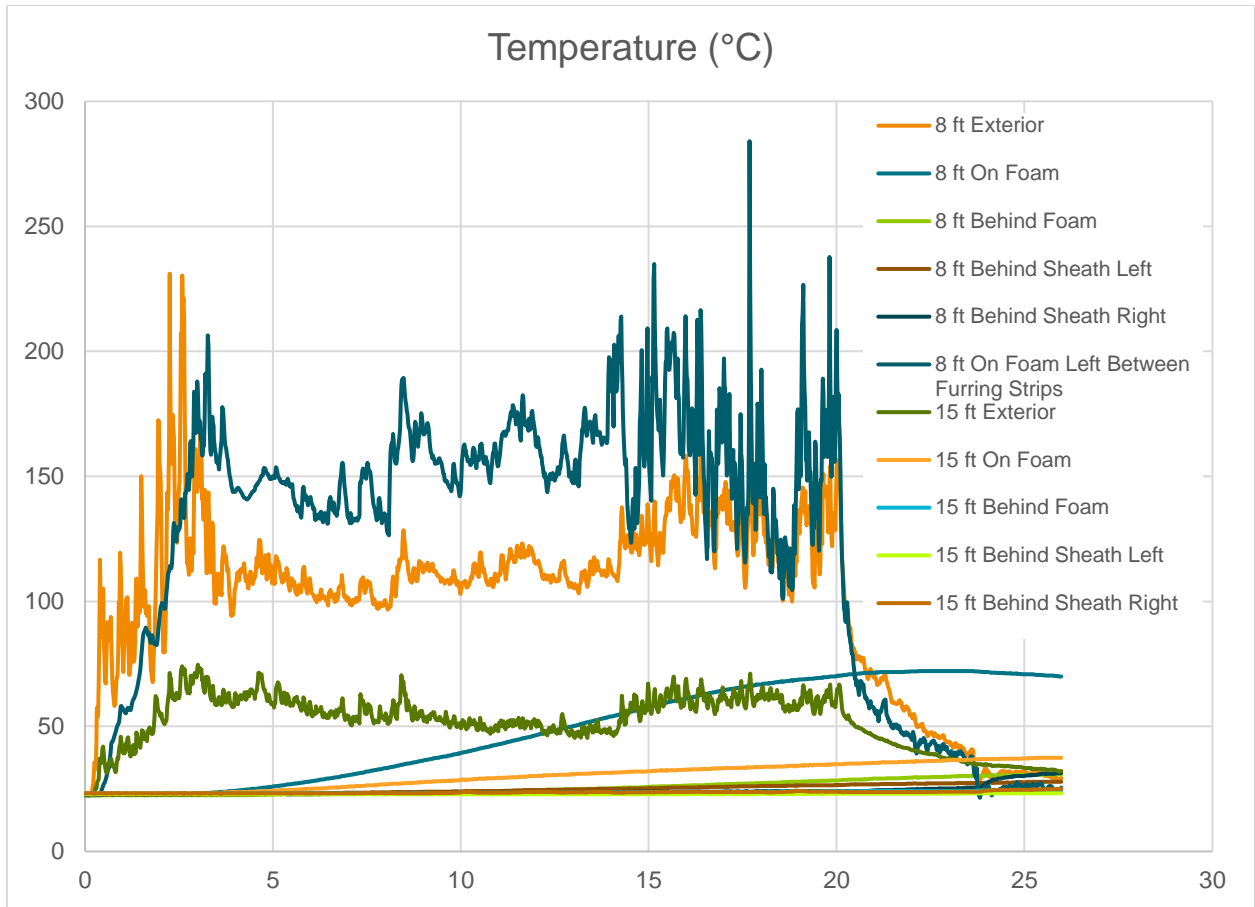
**Figure 107 - Test 11 Vinyl Siding/Furring Strips/Mineral Wool Temperature Plot (Metric Units)**
